Front Steering Rod Maintenance / Issues

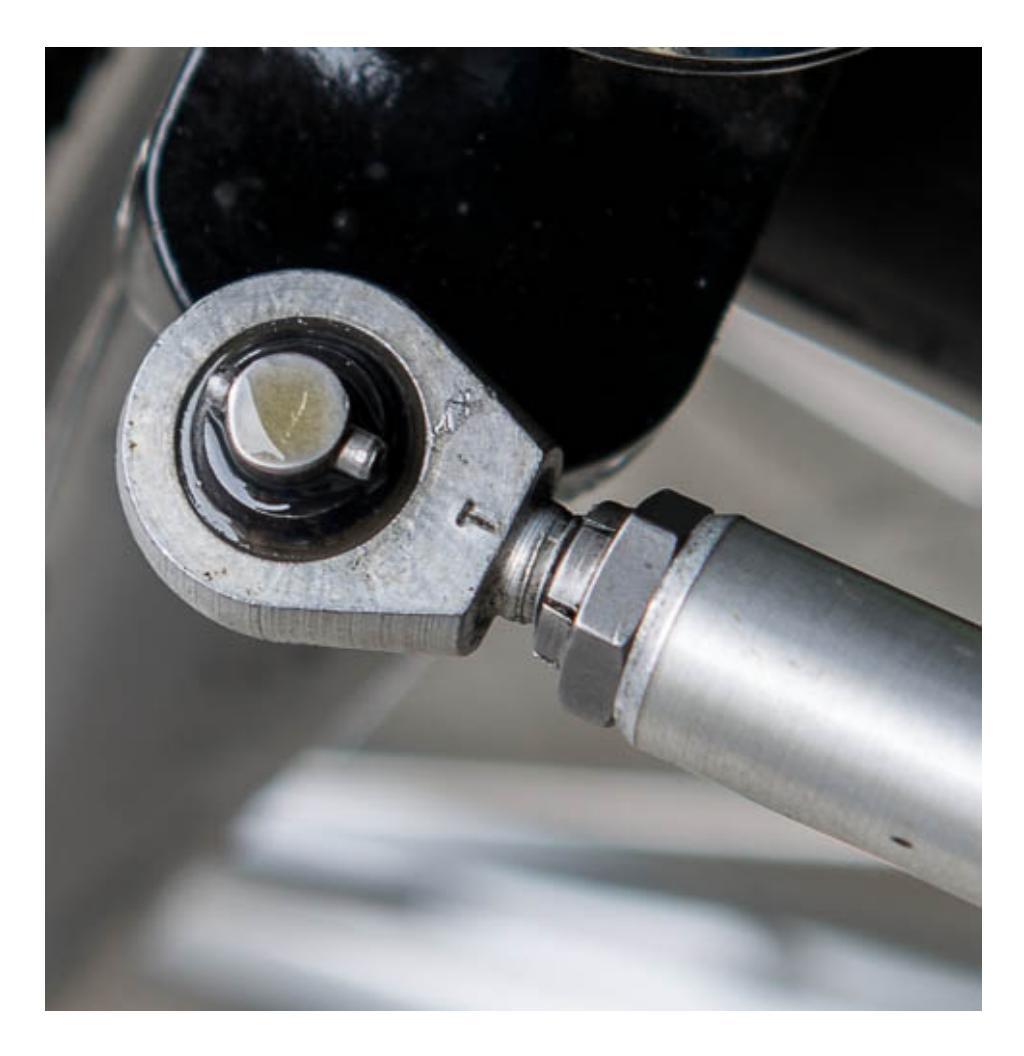
Many or most of the Avatars that still exist out there have probably never needed specific attention paid to the ball rod-end of the steering that attaches to the front fork.

Many bikes have probably sat unused for many years. If that environment was damp, some or all of the time, there is a good possibility that the inner 'ball' of the rod-end has rusted to the custom stud on the fork. Both steels are susceptible to rust as they are made of common steel. Of course, the rod end still functions as all the movement is at the outer part of the ball against whatever material the rod-end was incorporates. My 037 bike that was Len Vreeland's back-up never had the need for the rod-end to be removed. Eventually, in deciding to replace it with a new one, I found the ball frozen to the stud and an attempt to remove it with a small puller actually pulled the outer part of the rod-end off of the ball. (there was plastic liner that served as the bearing material) The only

way to get the ball off of the stud was to carefully take a hacksaw and saw down next to the stud on both sides and it then fell off with a tap.

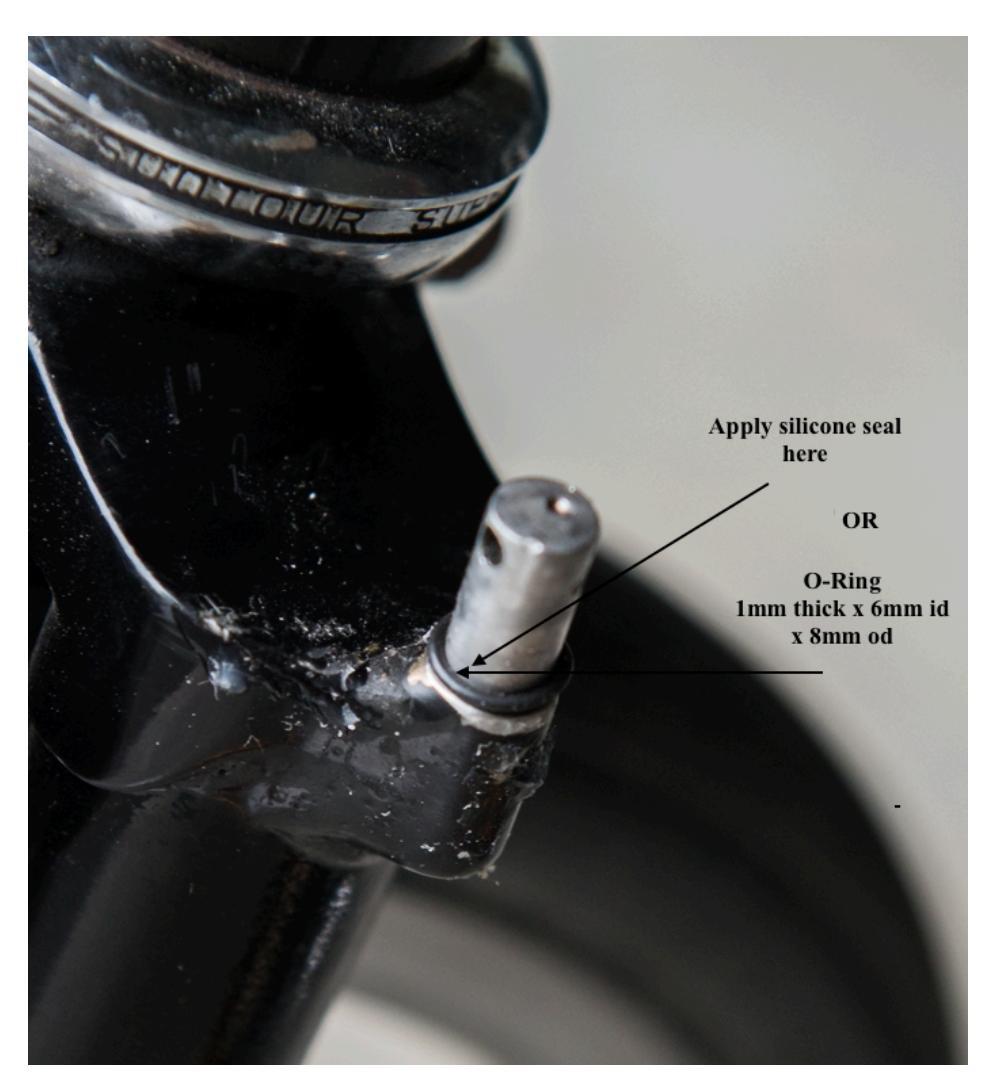
The rod-end had a little bit of excess play that was part of a metallic 'rattle' heard while riding. The new rod-end rattled more than ever! I have found the clearance between the top of the rod-end and the roll-pin was the real source of the rattle. We are talking small clearances here – no more than about 1/32".

I have found 2 solutions. Probably the simplest and cheapest is to use some 100% silicone seal. With the steering rod-end removed, clean the stud well (I use electrical spray cleaner) and apply a small amount of silicone to mostly the bottom circumference of the stud and allow to dry. That should allow you to push the rod-end down far enough for the 3/32" roll-pin to be installed.

The other solution is to go to the trouble of obtaining a small o-ring. I have tried both methods. I currently have an o-ring $1 \text{mm} \times 6 \text{mm}(i.d.) \times 8 \text{mm}(o.d.)$ on the bike and it is working fine but if it ever begins to rattle again, I will go back to the silicone.
